Complications Associated with Excess Cement Around Crowns on Osseointegrated Implants: A Clinical Report

The potential advantages and disadvantages of cement-retained implant crowns are reviewed, with a focus on complications related to residual excess cement. A series of 4 case reports illustrates the symptoms and treatment modalities associated with excess cement around implant crowns, and suggestions are offered for the prevention of such problems.

(INT J ORAL MAXILLOFAC IMPLANTS 1999;14:865–868)

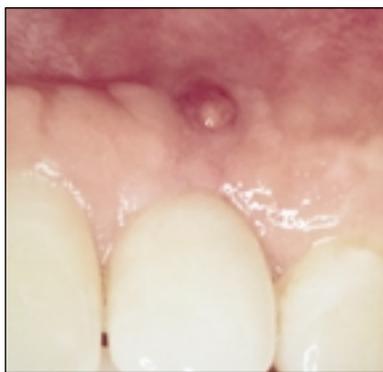
Fig 1a Maxillary left lateral incisor with buccal swelling and purulent discharge.

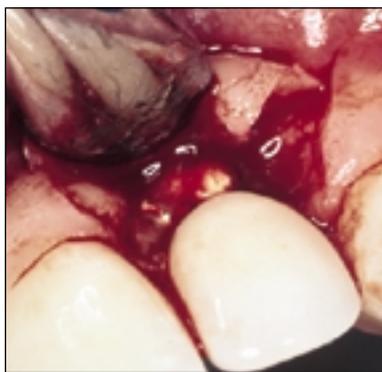
Fig 1b Excess cement noted at implant-abutment interface of same tooth.

tion period was unremarkable, and at the time of abutment placement, complete bone coverage was noted, extending over the cover screw of the implant. A CeraOne abutment was placed, and the tooth was then restored with a single all-ceramic crown. The patient was lost to recall for almost 4 years, and when next seen he demonstrated a localized purulent swelling of the facial aspect of the peri-implant soft tissue (Fig 1a). Consultation with his general dentist revealed that the implant crown had been displaced some weeks previously and had been recemented. He related that it was difficult to seat the crown at cementation. A flap was raised in this area, and an excess of zinc phosphate cement was noted around the circumference of the implant (Fig 1b). The crown was found to be incompletely seated but was resistant to removal. The excess cement was removed, and the flap was replaced (Fig 1c). Soft tissue healing was uneventful. Replacement of the crown was recommended.

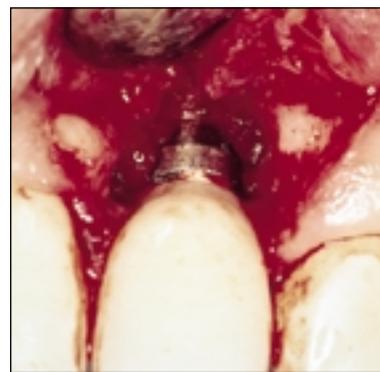
Fig 1c Excess cement was removed and the area debrided.

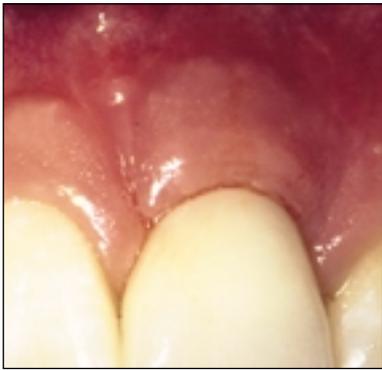
Fig 2a Maxillary central incisor with buccal swelling of gingival tissues around implant crown.

Case #2. A 23-year-old male presented for implant restoration of a missing maxillary central incisor, which had been lost as a result of trauma. A single Brånemark implant was placed, measuring 3.75×15 mm, and after a 9-month integration period, a CeraOne abutment was placed. The implant was subsequently restored with a crown cemented with Fuji II glass-ionomer cement (GC International, Kitchener, Ontario, Canada). Some weeks later, the patient presented with an acute swelling of the gingival tissues around the implant crown (Fig 2a). A 9-mm probing defect was noted facially, and marginal bone loss was seen on radiographic examination. On exposure of the area by flap procedure, a small excess of cement was noted

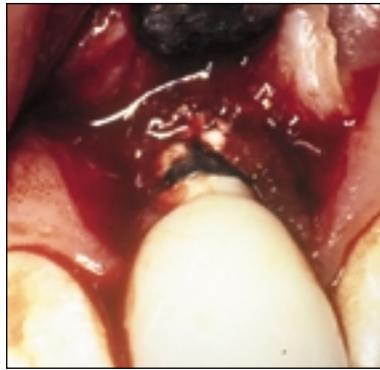
Fig 2b Small amount of excess cement at implant-abutment interface.

at the abutment-crown interface (Fig 2b). This excess was removed, and the flaps were replaced (Fig 2c). Subsequent healing was uneventful, although some gingival recession was noted. The implant remains integrated, and there have been no further complications.

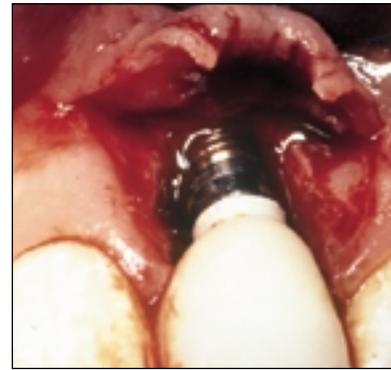
Fig 2c Excess cement was removed and the area debrided.
