Endosseous Implant Failure Influenced by Crown Cementation: A Clinical Case Report

Implant dentistry has developed predictable treatment outcomes. Nevertheless, there are multiple reasons for implant failure. This case report documents a previously unreported type of implant failure that occurred 1 month after crown cementation. The implant failure is believed to be associated with retained excess subgingival cement. INT J ORAL MAXILLOFAC IMPLANTS 2008;23:943–946

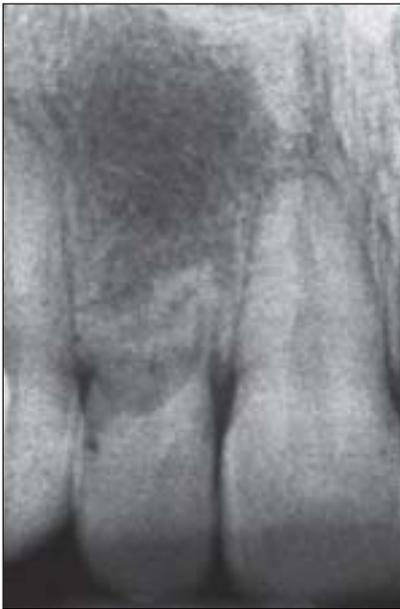
Fig 1 (Left) Baseline periapical radiograph. Note severe resorption of tooth in the maxillary right lateral incisor.

A 31-year-old Hispanic woman presented to the authors' periodontal office reporting mobility of the maxillary right lateral incisor. The medical history of the patient was noncontributory. The patient reported previous orthodontic therapy for 3 years. A periapical radiograph revealed severe root resorption (Fig 1). The treatment plan was to extract the maxillary right lateral incisor with immediate placement of an endosseous dental implant. After local anesthesia was obtained, the maxillary right lateral incisor was atraumatically extracted. The surgical site revealed an adequate amount of alveolar bone for immediate implant placement. The buccal alveolar bone was intact, and no signs of pathology or bone resorption beyond the socket of the remaining tooth fragment were noted.

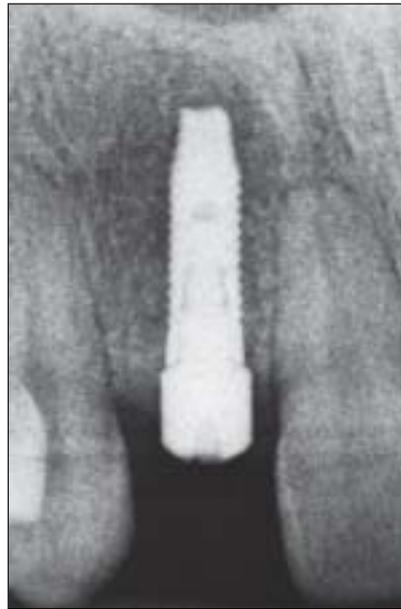
Fig 2 (Center) Implant placement at baseline (the day of the surgery).

Subsequently, a narrow, internal platform, parallel-walled endosseous implant was inserted (3.25×11.5 mm; Biomet 3i, Palm Beach Gardens, FL) using a surgical template (Fig 2). At the same visit, the healing abutment was inserted (3.4×4 mm) and a provisional removable partial denture was delivered. Postoperative medication included amoxicillin 500 mg every 8 hours for 10 days, chlorhexidine 0.12% every 12 hours for 7 days, and an acetaminophen/hydrocodone-based analgesic as needed for pain. The implant was allowed to heal for 4 months (Fig 3). Then, a reverse torque of 20

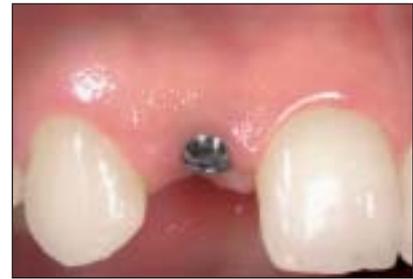
Fig 3 (Right) Clinical photograph demonstrating uneventful healing 4 months after implant placement.

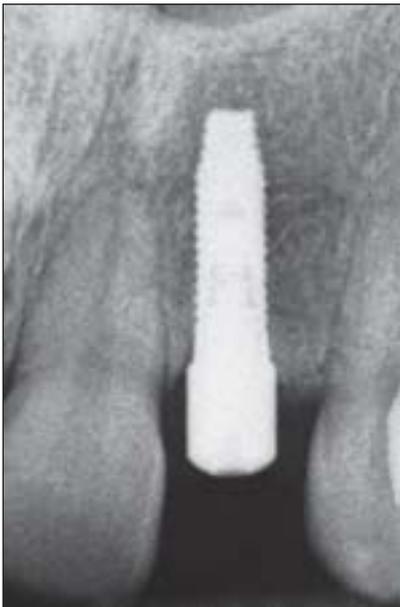
Fig 4 (Left) Four-month postoperative radiograph.

Ncm was utilized to ensure the implant was osseointegrated and a follow-up radiograph was obtained (Fig 4). The peri-implant sulcus was within normal range.

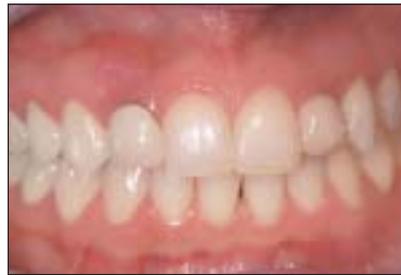
Fig 5 (Center) Clinical photograph approximately 1 month after crown cementation was performed. Note the erythematous and cyanotic tissues around the implant. A 9-mm peri-implant pocket with suppuration was detected on the distal aspect of the implant.

The patient returned to the periodontal office 1 month after final cementation of the implant prosthesis reporting soreness and swelling in the area (Fig 5). Clinically, a 9-mm pocket with suppuration was present on the distal aspect of the implant, while a shallow sulcus was present on the mesial aspect of the maxillary right canine. A radiograph at the same appointment revealed radiopaque material at the distal aspect of the implant in combination with

extensive bone loss (Fig 6). It was decided to remove the crown and prosthetic abutment and re-insert the healing abutment and provisional partial denture prior to exploration of the site. After local anesthesia was obtained, the area was surgically explored, revealing extensive bone loss distal and buccal to the implant (Figs 7a and 7b). There was a mixture resembling granulation material and temporary cement involving up to 70% of the implant length. The implant was surgically removed, and guided bone regeneration was performed at the site for a future dental implant.

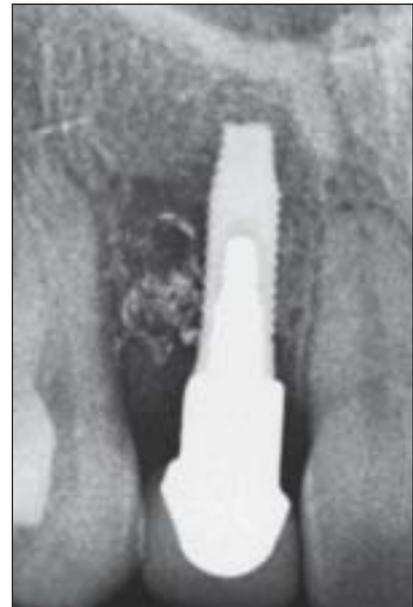
Fig 6 (Right) Radiograph taken approximately 1 month after crown cementation. Note the radiopaque material at the distal aspect of the implant in combination with extensive bone loss.

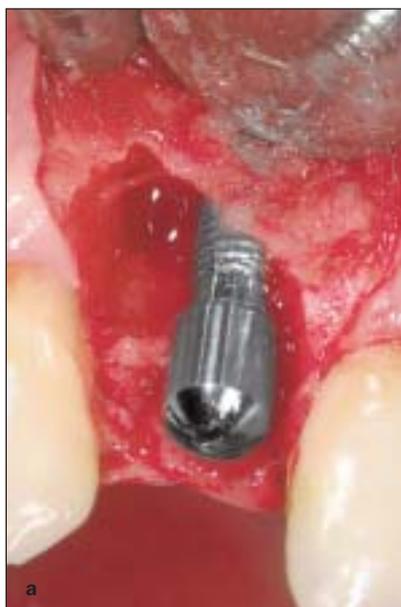
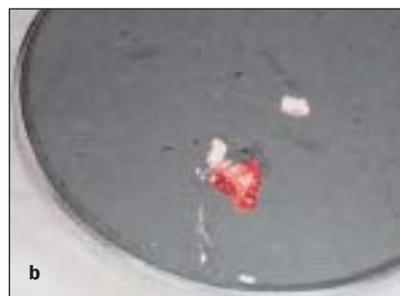
Figs 7a and 7b (a) Exploration of the defect revealed extensive bone loss at the distal and buccal aspects of the implant and material resembling temporary cement at the thread of the implant. (b) A mixture of granulation tissue with large amount of material resembling temporary cement was removed from the defect.

Cementation of implant-supported crowns is common in the esthetic zone. It is recommended that the restorative dentist be especially vigilant to remove excess subgingival cement following cementation of the crowns to avoid the potential for implant failure. The biologic process by which the cement is found within the intraosseous defect requires further study.
